COLORADO DEPARTMENT OF PUBLIC HEALTH
AND ENVIRONMENT

SITE INSPECTION

~~DRAFT~~ *P65*ANALYTICAL RESULTS REPORT

UPPER ANIMAS WATERSHED (CERCLIS ID # CO0001411347)

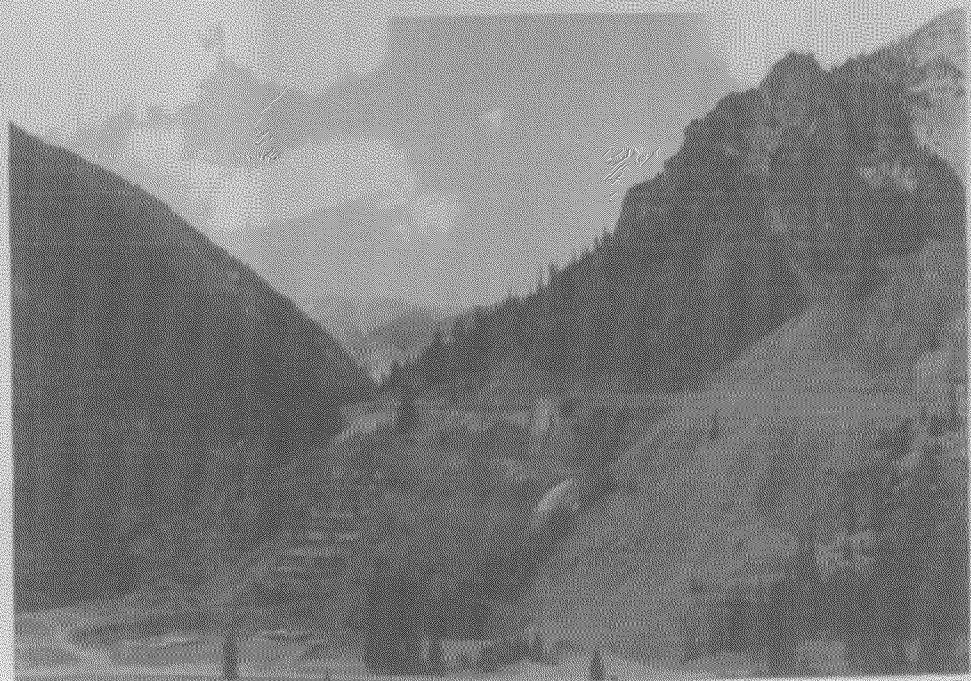
Description of Photo: SO-38 Eureka Mill Mine waste pile
Date: August 13, 1997 Time: 1400
Direction facing: Northwest (35mm film)

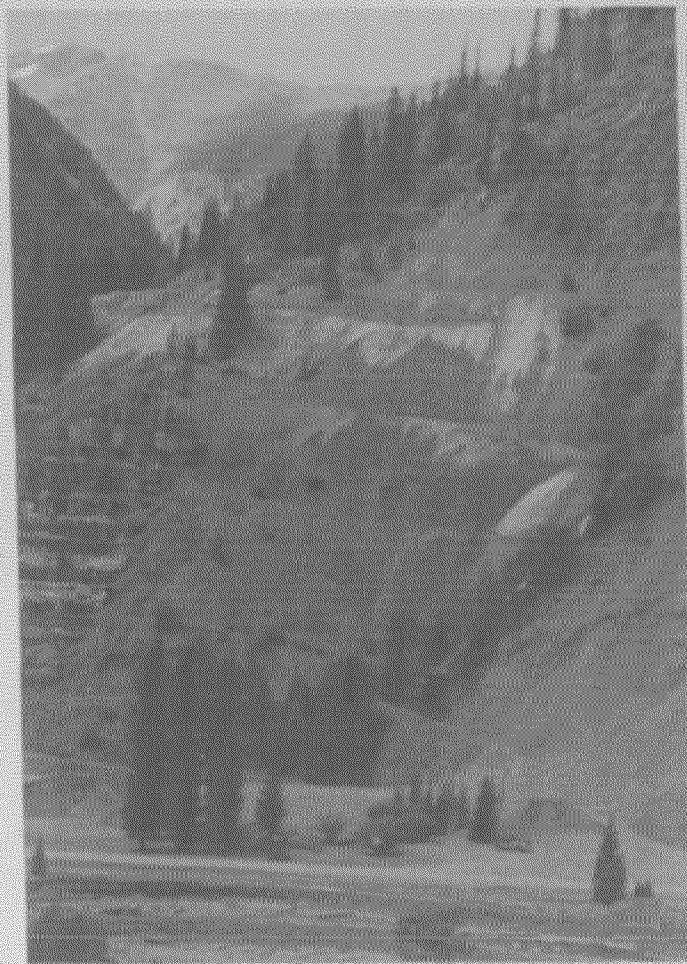
Description of Photo: SO-39 Eureka Mill Mine Waste pile
Date: August 13, 1997 Time: 1400
Direction facing: Northwest (35mm film)

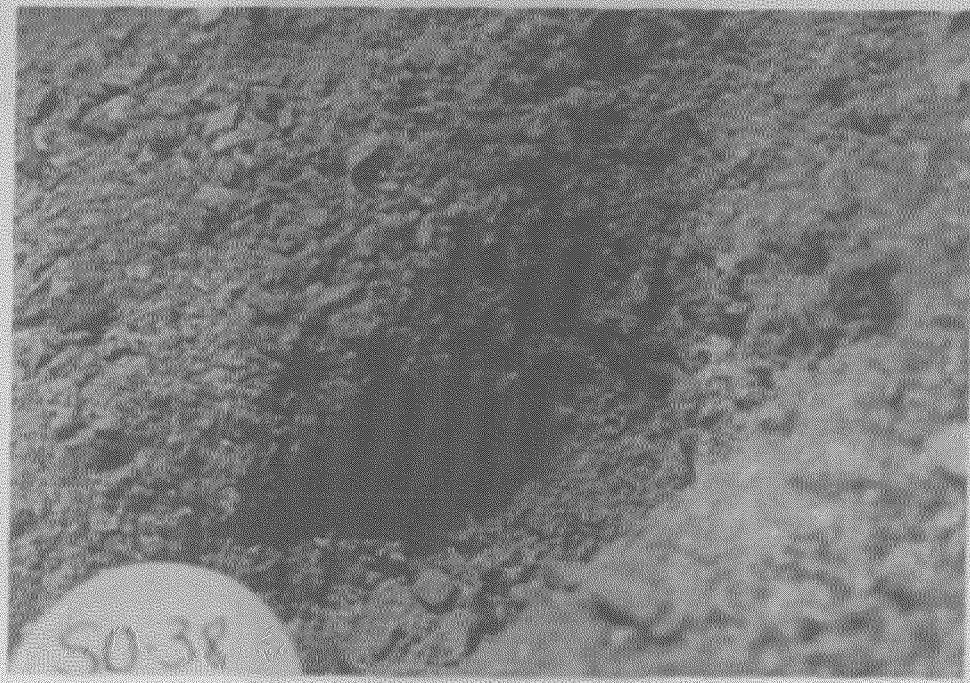
Description of Photo: 50-38 Eureka Mill Mine waste sample
Date: August 13, 1997 Time: 1430
Direction facing: Northwest (30mm film)

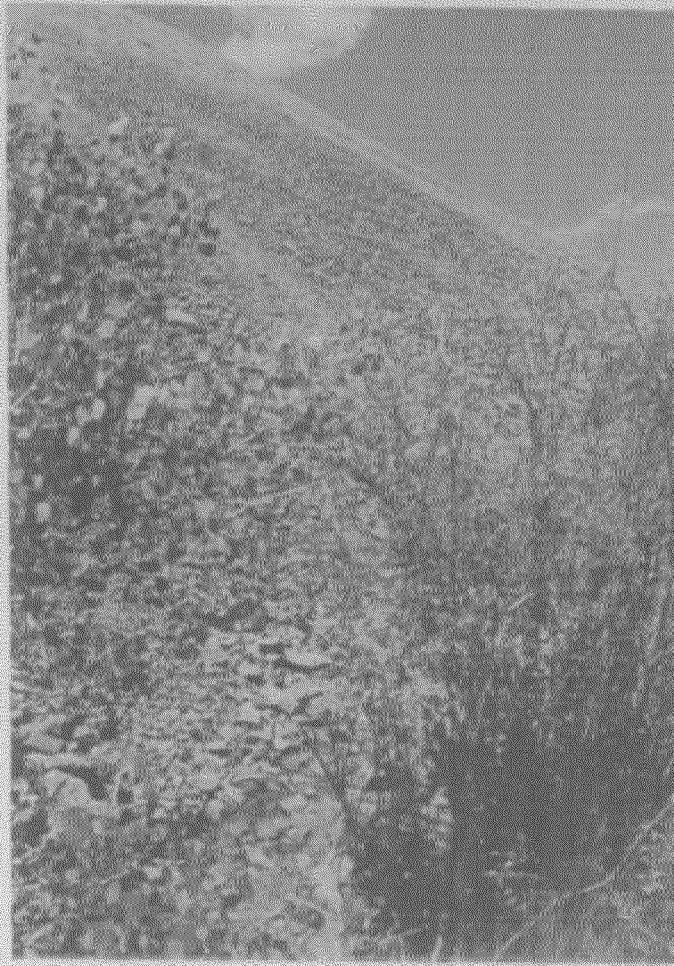
Description of Photo: 50-38 Eureka Mill Mine drainage
Date: August 13, 1997 Time: 1430
Direction facing: Northeast (30mm film)

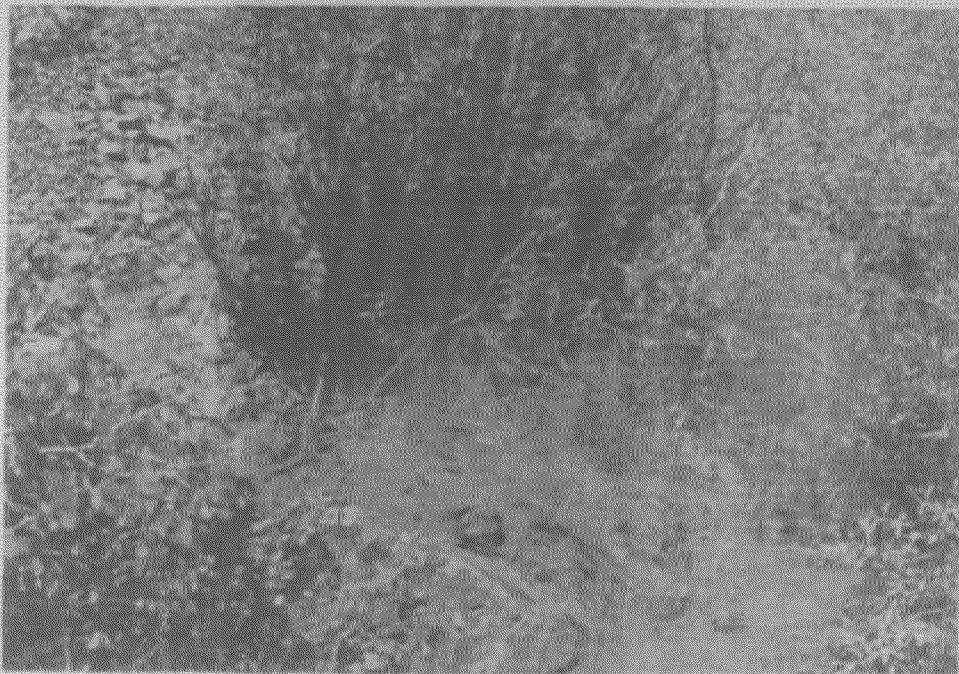
Description of Photo: SO-36 Eureka Mill Mine drainage
Date: August 13, 1997 Time: 1000
Direction facing: Northeast (30mm film)

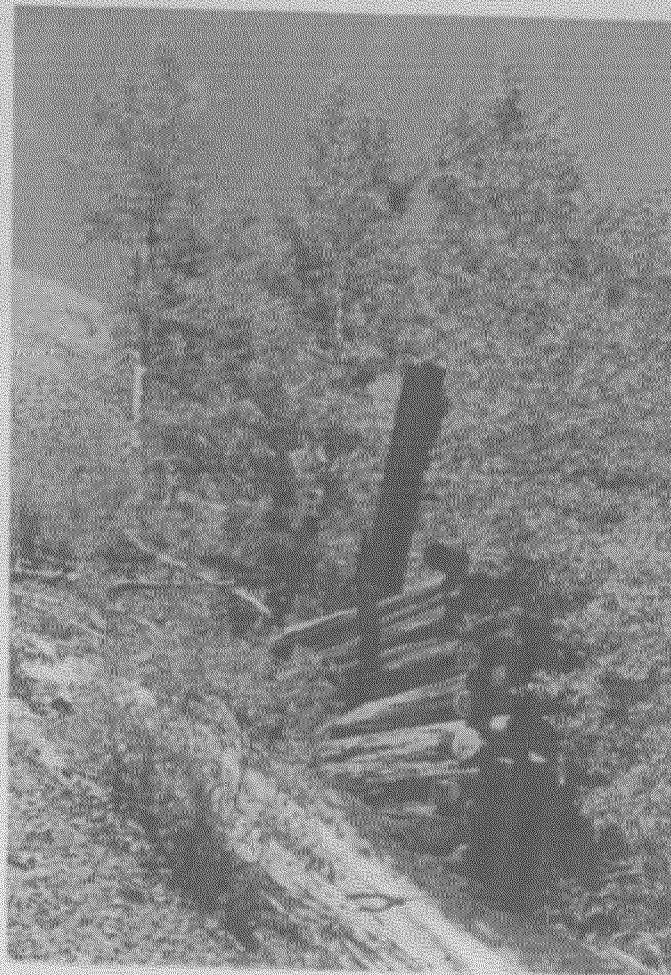
Description of Photo: SO-36 Eureka Mill Mine drainage
Date: August 13, 1997 Time: 1000
Direction facing: Northeast (35mm film)

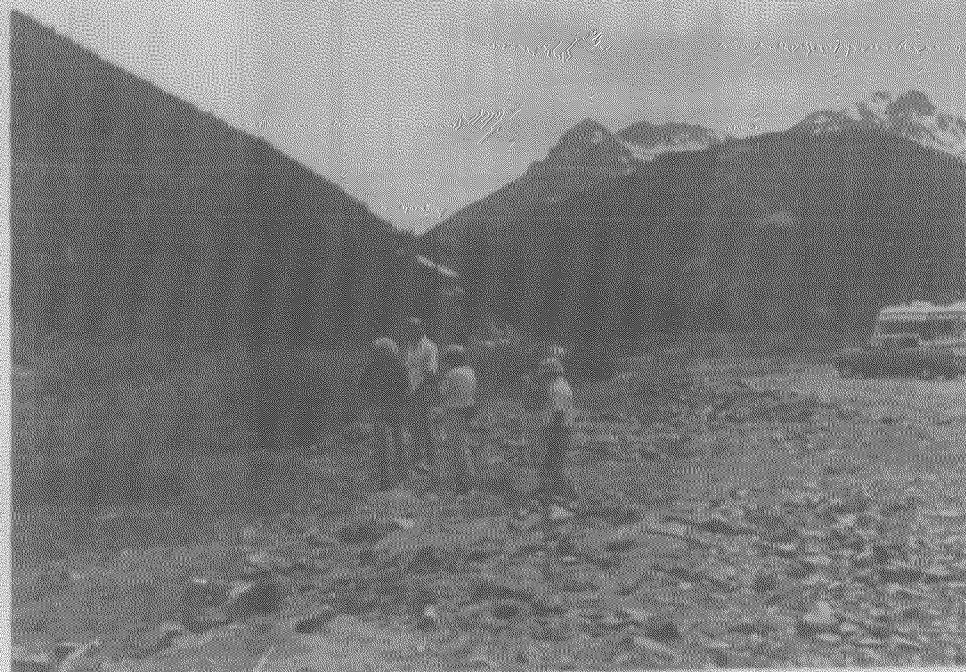
Description of Photo: GW-1 Silverton City Campground
Date: June 19, 1997 Time: 1430
Direction facing: Southwest (35mm film)

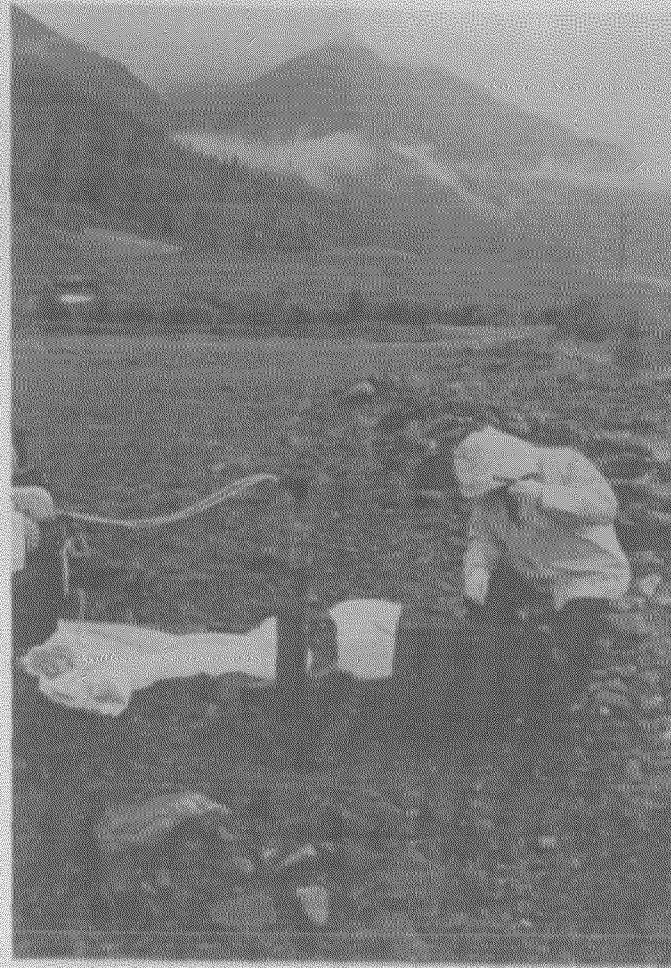
Description of Photo: GW-1 Silverton City Campground
Date: September 15, 1997 Time: 0945
Direction facing: Northwest (35mm film)

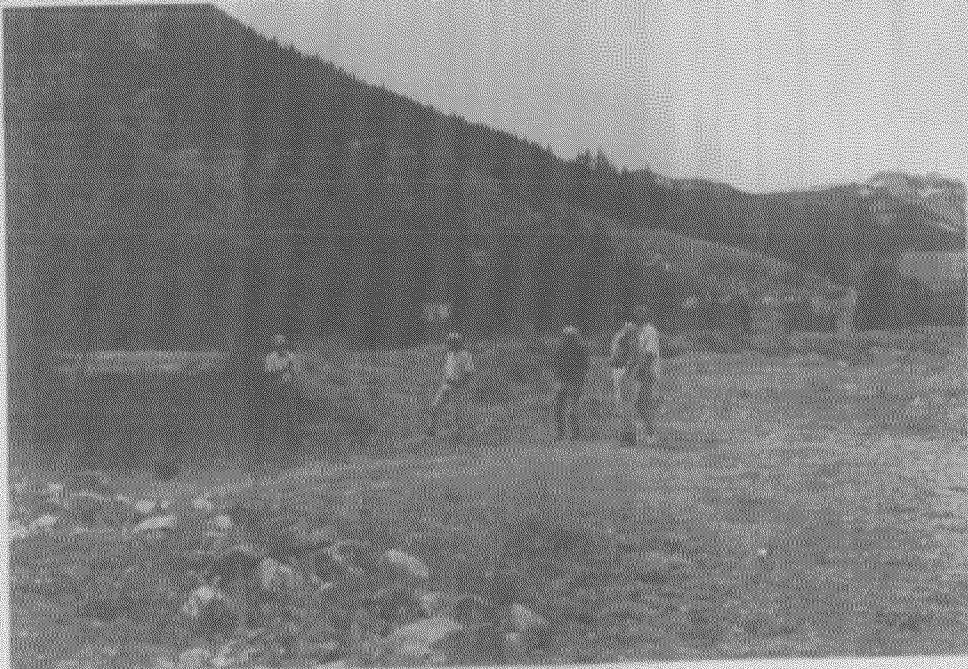
Description of Photo: GW-2 Silverton Memorial Park (Cement Creek)
Date: June 19, 1997 Time: 1430
Direction facing: Northwest (35mm film)

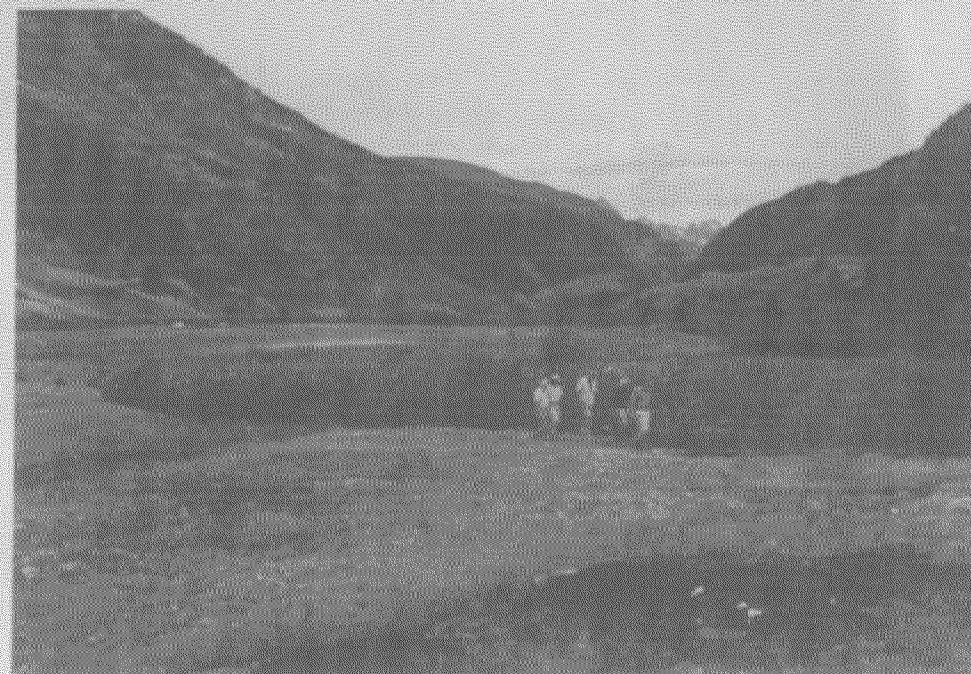
Description of Photo: GW-3 Silverton Sewage Treatment Plant (Mineral Ct)
Date: June 19, 1997 Time: 1430
Direction facing: Southwest (35mm film)

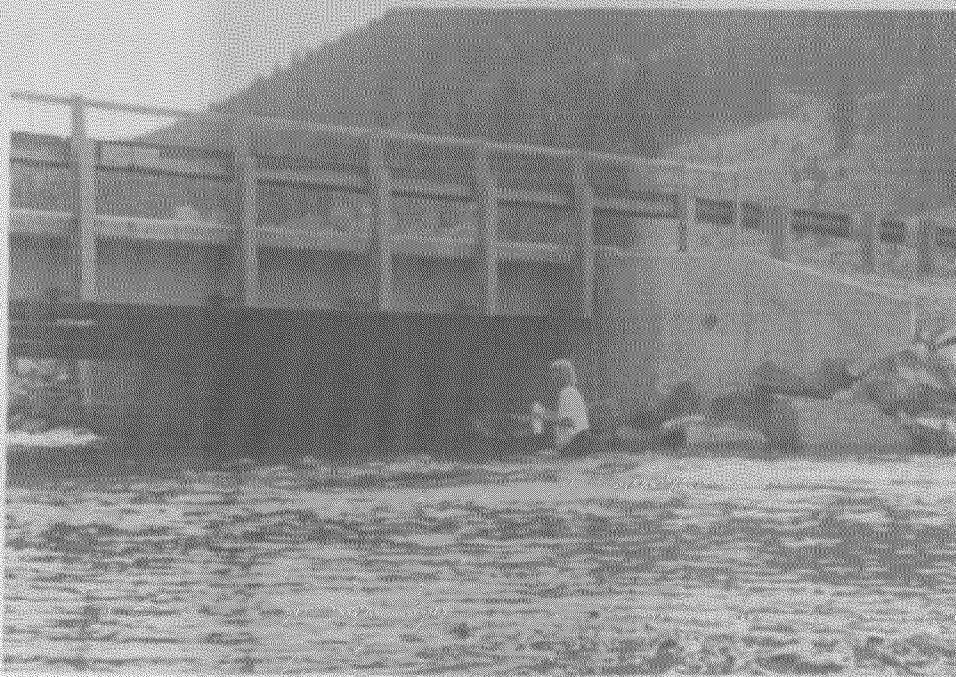
Description of Photo: SW/SE A-68 Animas River above Cement Cr.
Date: September 4, 1987 Time: 0930
Direction facing: Northwest (35mm film)

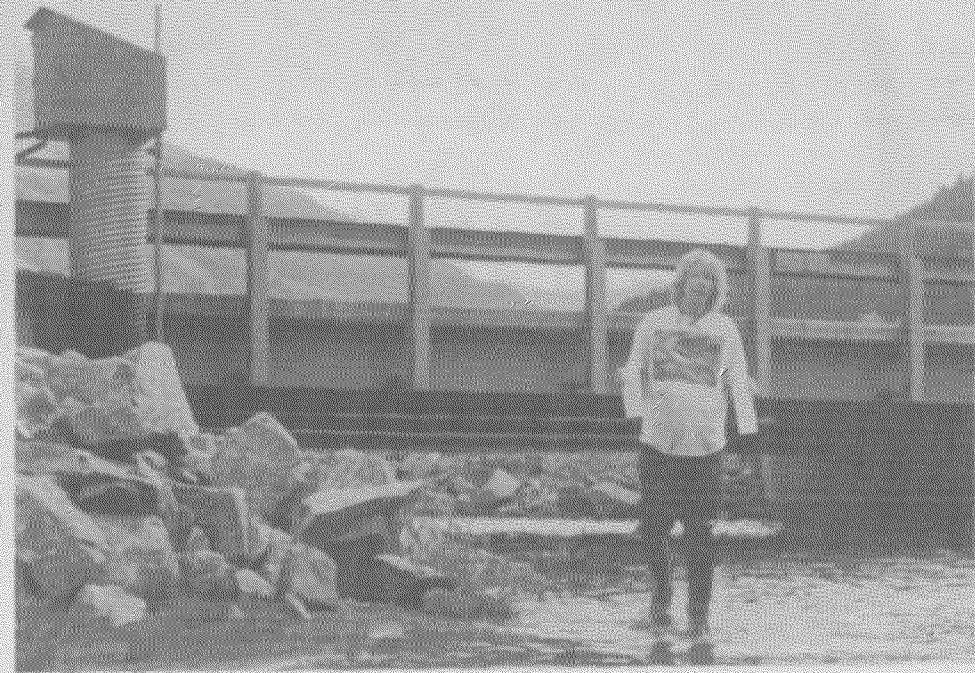
Description of Photo: SW/SE A-68 Animas River above Cement Cr. a
Date: September 4, 1987 Time: 0930
Direction facing: Northeast (35mm film)

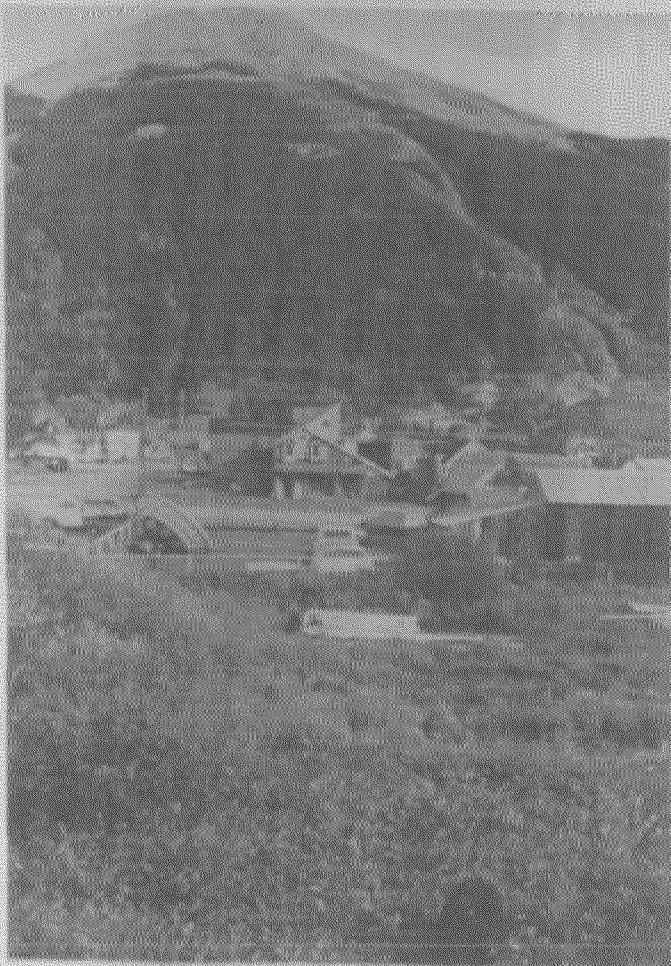
Description of Photo: OP-ST-1 Residential Soil N. of 557 Reese
Date: September 16, 1997 Time: 1715
Direction facing: East (35mm film)

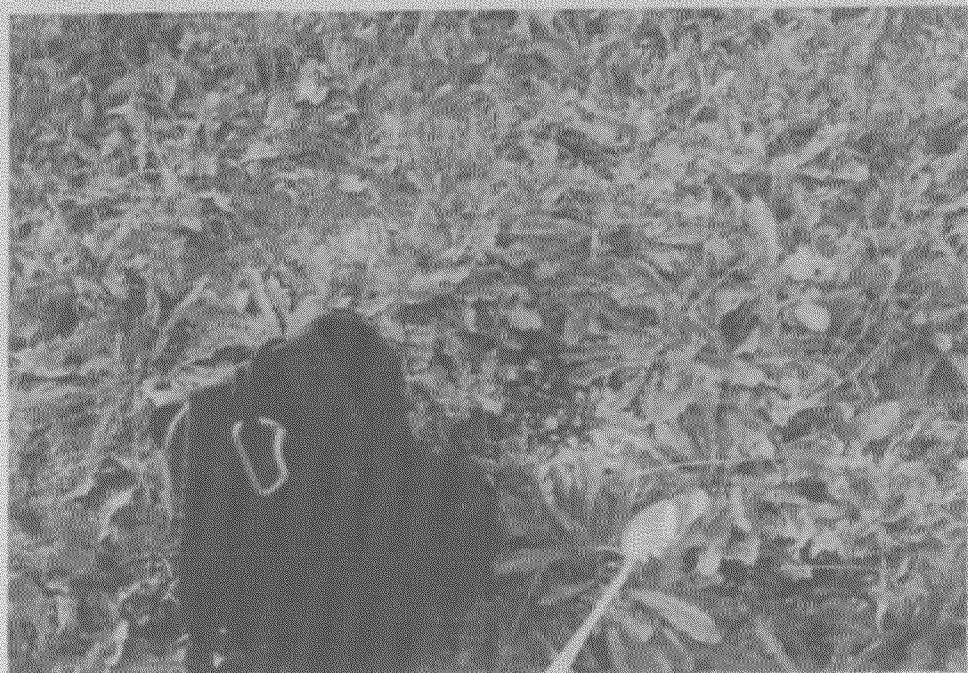
Description of Photo: OP-ST-1 Residential Soil N. Of 557 Reese
Date: September 16, 1997 Time: 1715
Direction facing: West (35mm film)

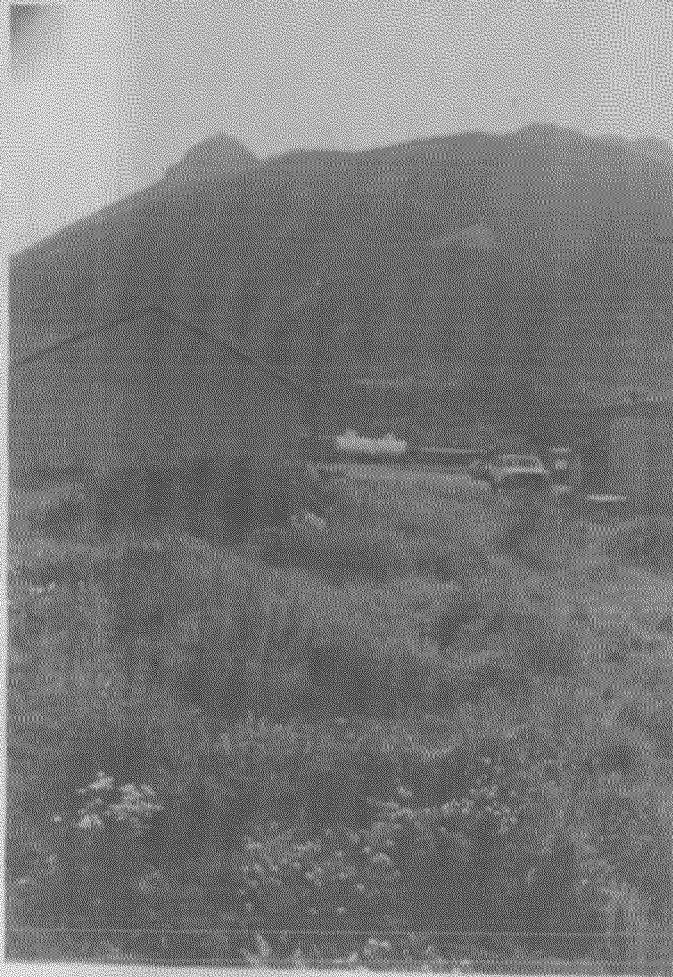
Description of Photo: DP-SL-2 Residential Soil @ 10th and Bluff
Date: September 16, 1997 Time: 1645
Direction facing: Southwest (25mm film)

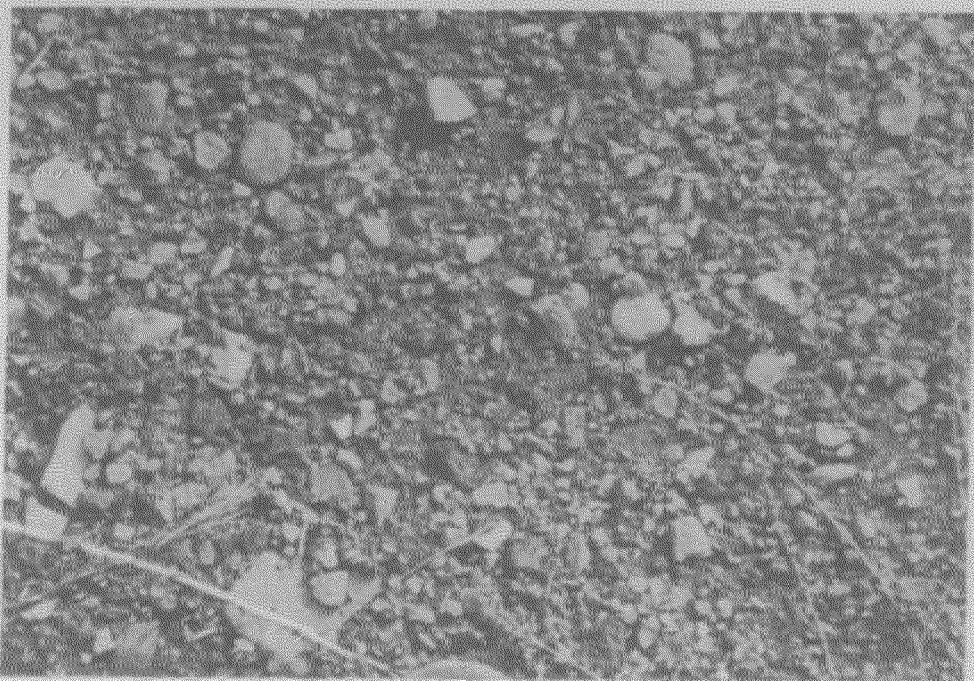
Description of Photo: DP-SL-2 Residential Soil @ 10th and Bluff
Date: September 16, 1997 Time: 1645
Direction facing: Southwest (25mm film)
